# Wear in Two Cases of Ceramic on Ceramic Total Hip Arthroplasty After 30 Years Follow Up

**Case description:** We have analysed two cases of ceramic head on ceramic liner of Autophor primary THA implanted in active patients and retrieved for aseptic loosening after 34 and 31 years of well function. The sphericity, surface roughness and microtopography was assessed by a profilometer and a white light interferometer. Scanning electron microscopy of the implant-retrieved surfaces was also performed.

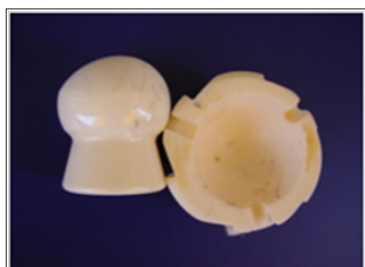
**Figure 1:** Clinical case 1: Macroscopic wear of the retrieved CoC THR first generation retrieved liner.

The femoral heads showed stripe wear and varying degrees of roughened or darkened areas (Figures 1-4). Surface topography of the femoral heads and acetabular cups showed that the unworn areas had a very smooth surface, but the roughened and areas with stripe wear had more peaks and troughs. The calculated lineal wear of the first clinical case head was 41.4µm/year. On the second clinical case, the estimated lineal wear was 48.3µm/year for the head and 18.5µm/year for the socket. Microscopic wear was assessed by quantifying the surface roughness of liners and femoral heads. The average surface roughness was of 549.76±91.25 nm for the head of the first clinical case and 449.96±141.72 nm for the head of the second one in the worn areas. The average surface roughness in the unworn areas was 93.35±70.90 nm for the first clinical case and 79.89±88.97 for the second one. The SEM examination showed abrasive wear. The maximum deviation of the sphericity observed was 3.7% in the head and 2.9% in the socket on the clinical case 1.

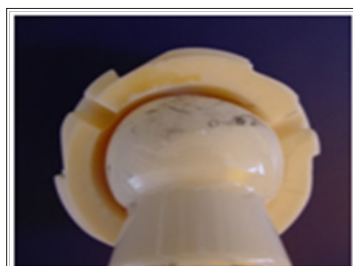
**Figure 2:** Clinical case 1: Macroscopic wear of the retrieved CoC THR first generation retrieved femoral head.

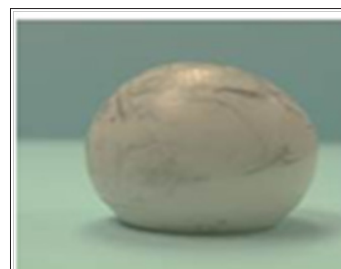
**Figure 3:** Clinical case 2: Macroscopic wear of the retrieved CoC THR first generation retrieved femoral head.
