# Fracture and Fatigue of Titanium Narrow Dental Implants: New Trends in Order to Improve the Mechanical Response

**Abstract:** Sixty-four fractured commercially pure titanium (cp-Ti) narrow dental implants (NDIs) with similar macrogeometry and connection designs were studied after different implantation times in humans in order to determine their reliability and to evaluate the causes of the fracture. These NDIs were compared with other similar implants, made with alloyed titanium with 15% Zr and with 12% strained titanium. Original implants were tested under static and fatigue conditions, simulating the tri-axial loads in the mouth by means of a Bionix hydraulic test machine. Fractography was studied using field-emission scanning electron microscopy (FSEM). The results showed that cp-Ti NDI exhibits low strength for mechanical cycling, and the alloyed Ti and strained titanium increase the mechanical strength, guaranteeing long term mechanical behavior. NDIs fractured due to fatigue, and, in some cases, the presence of cracks in the original NDIs quickly led to fracture. These cracks were attributed to plastic deformation during machining were found to be exacerbated due to acid

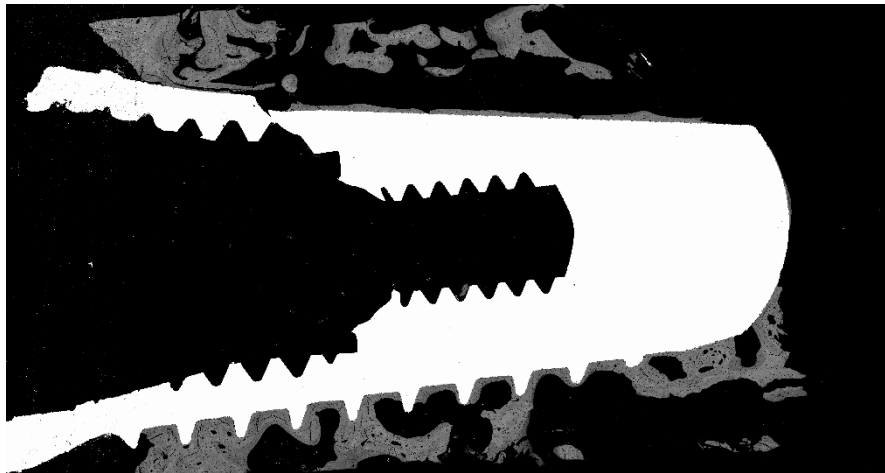
The mechanical strength of cp-Ti is limited and its use in NDIs increases the risk of fracture of the Ti dental implant [7–9]. In Figure 1, the fracture of an osseointegrated NDI after 17 months of implantation in a patient can be observed. The small diameter and reduced wall thickness, and the lower material bulk hamper the long-term survival. Furthermore, the bending of the prosthetic components increases, thereby decreasing the restoration reliability.

**Figure 1.** SEM micrographs of a narrow dental implant (NDI) fractured 17 months after implantation in a patient. The fracture is located in the connection zone where the cross-sectional surface is lower.

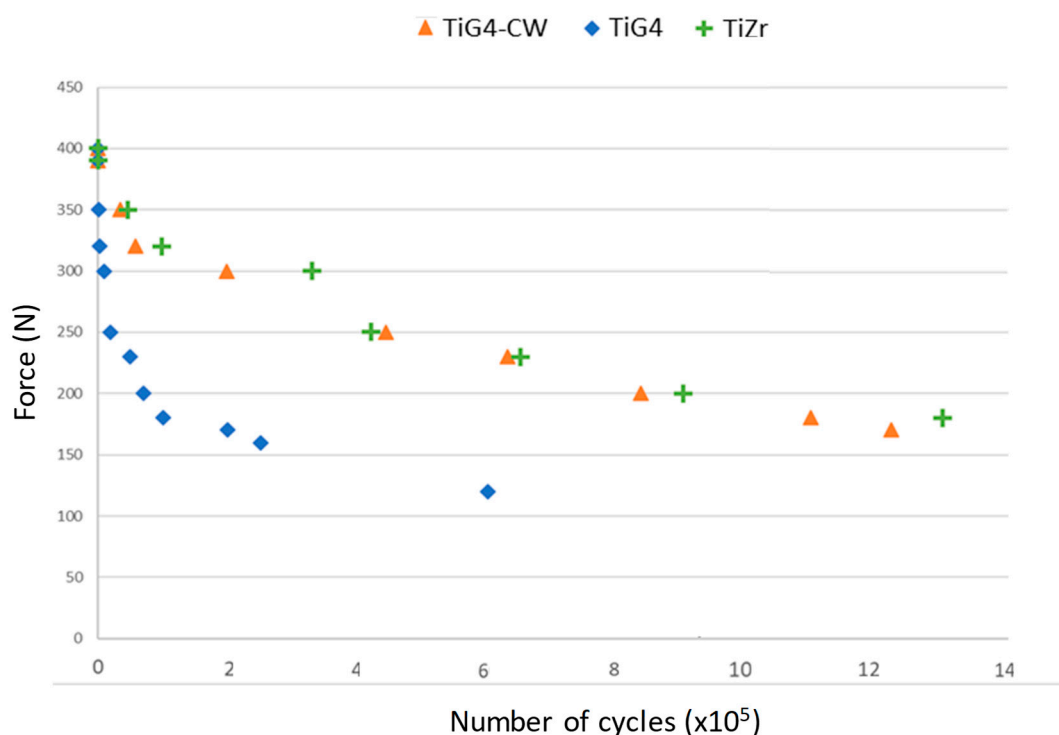
In fatigue tests, material behavior is commonly characterized by an S–N curve, which describes the magnitude of a cyclic force or stress (S) as a function of the number of cycles to failure (N). A value under the curve suggests that a dental implant will not fracture. Figure 2 shows the S–N curve for the different NDIs studied. The results show that the implants alloyed with Zr and those with Ti grade 4 submitted to 12% cold working presented more fatigue life than the Ti dental implants (grade 4) without hardening treatment. The cold-worked or alloyed implants presented an asymptotic curve around 200 N. However, the cp-Ti grade 4 presented a curve around 100 N. These values demonstrate the importance of the static mechanical properties on the cyclic behavior. This aspect is very important in clinical applications, whereby cp-Ti for NDIs would produce premature fractures when chewing loads exceed 100 N.

**Figure 2.** S–N curves (stress vs. number of cycles) of the different NDIs studied.

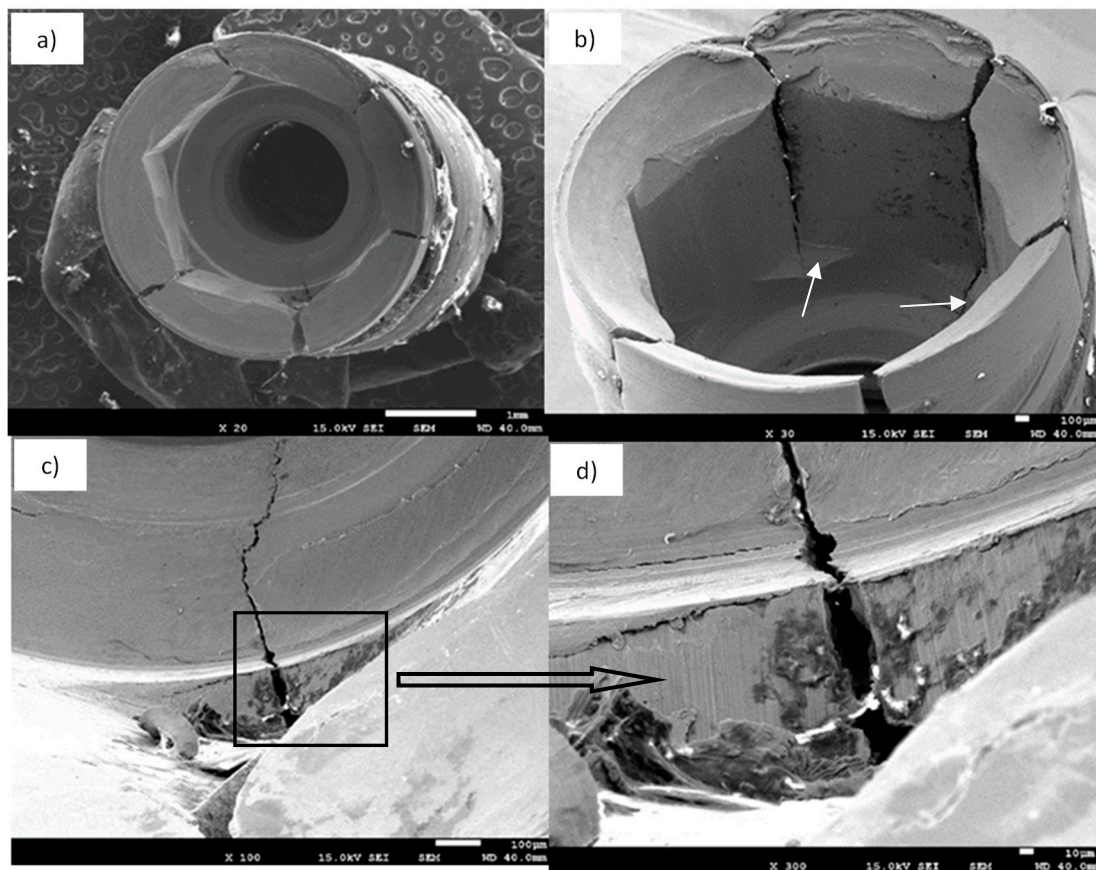
For NDIs which fractured after being inserted in patients, it can be observed that the fracture mechanism was fatigue in all cases. The fractography can be observed in Figure 3, with different SEM micrographs showing a detailed description of both crack nucleation points and crack propagation paths. Figure 3 shows the presence of many longitudinal cracks along practically all vertices between the walls of the inner hexagonal connection [25–27].

**Figure 3.** SEM fractography of explanted cp-Ti grade 4 NDIs: (a) SEM micrograph of an explanted implant, top view; (b) SEM micrograph of hexagonal inner connection (side view) showing longitudinal fracture cracks; the white arrows mark the places of crack nucleation; (c,d) SEM micrographs showing crack propagation at different magnifications.

The crack nucleation was generated inside the implant body, specifically in the inner hexagonal connection walls just inside the bottom horizontal ground plane. After crack nucleation, progressive crack growth produced under cyclic masticatory multiaxial loading was responsible for the propagation path along the vertices of hexagonal connections, as well as through the walls, as can be seen in Figure 3b [28–30].

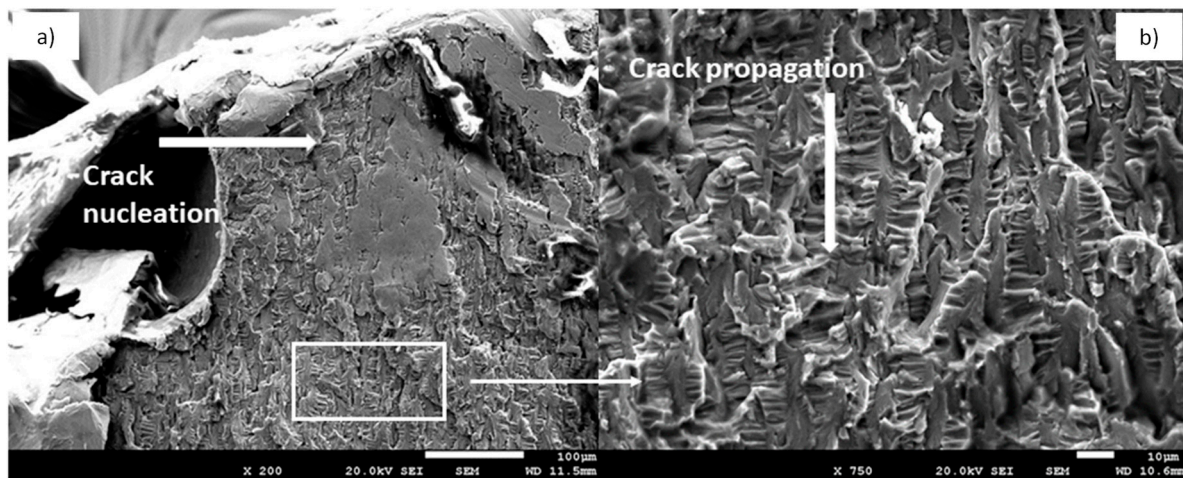
From Figure 4a, the site of crack nucleation can be observed, as well as a site where crushing occurred, due to the friction between the fracture surfaces in the crack propagation. This was the least effective surface to which the load was applied and, consequently, this was the point of maximum stress which provoked crack nucleation in the load cycle. The subsequent crack propagation was fast due to the cyclic loads, leading to fracture. In Figure 4b, the typical striation or fatigue marks indicating the direction of crack propagation can be observed [15–18,29].

**Figure 4.** SEM micrographs of the cpTi grade 4 NDI showing crack nucleation and propagation: (a) SEM micrograph showing crack nucleation starting point, (b) SEM micrograph showing crack cyclic propagation due to fatigue.

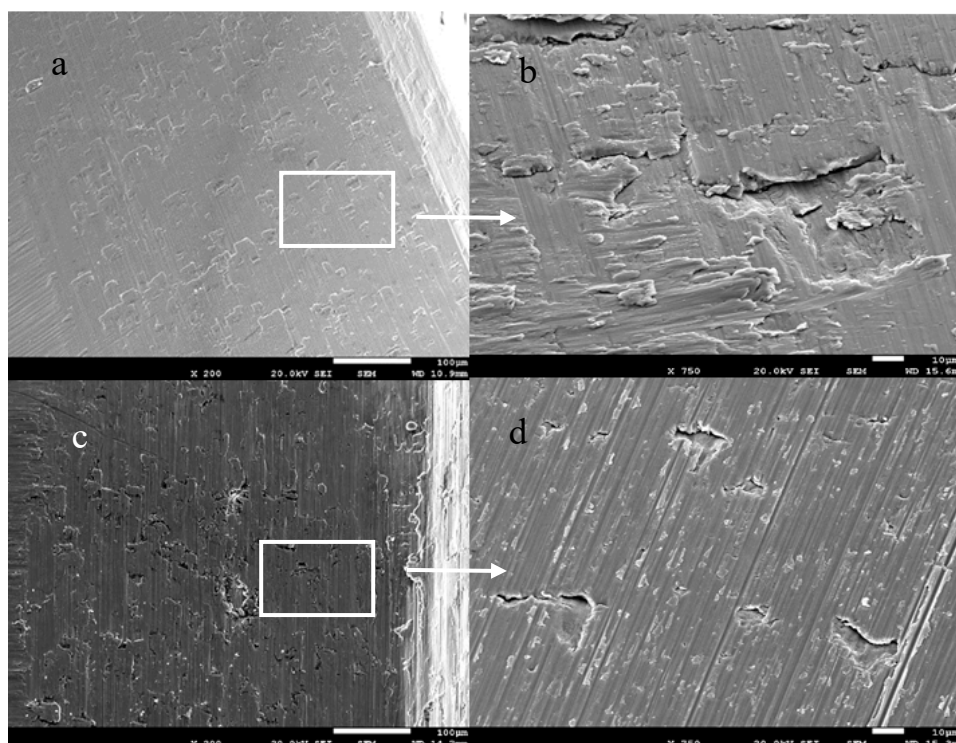
One cause of premature fracture in the cp-Ti NDIs was the poor mechanical properties, especially in the connection zone, in relation to the other implants, which had higher strength and fatigue limits. On the other hand, in the manufacturing process, the conformation of hexagonal connections results from plastic strain. This plastic strain produces small defects, as shown in Figure 5. These defects present a higher residual energy and are the points of crack nucleation. Furthermore, the implants are treated with acids in order to increase their roughness, so as to improve osseointegration and passivate the dental implant. Sometimes, acid etching is used to color the connection, thereby helping the surgeon identify the pieces for prosthesis. These acids, therefore, etch the defects and produce cracks

before the insertion of the implant into the patient. When the implant is inserted, crack propagation starts due to chewing cyclic loads until fracture occurs [19–21,30–32].

**Figure 5.** SEM micrographs of inner cp-Ti grade 4 implant connection, showing some plastic deformation and crack formation on the connection surface due to “broaching”. (a). Defects in the internal surface. (b). Defects with more detail from 5a. These defects are the place of the crack nucleation. (c). Defects in the internal surface with more plastic deformation. (d). These defects are cracks.

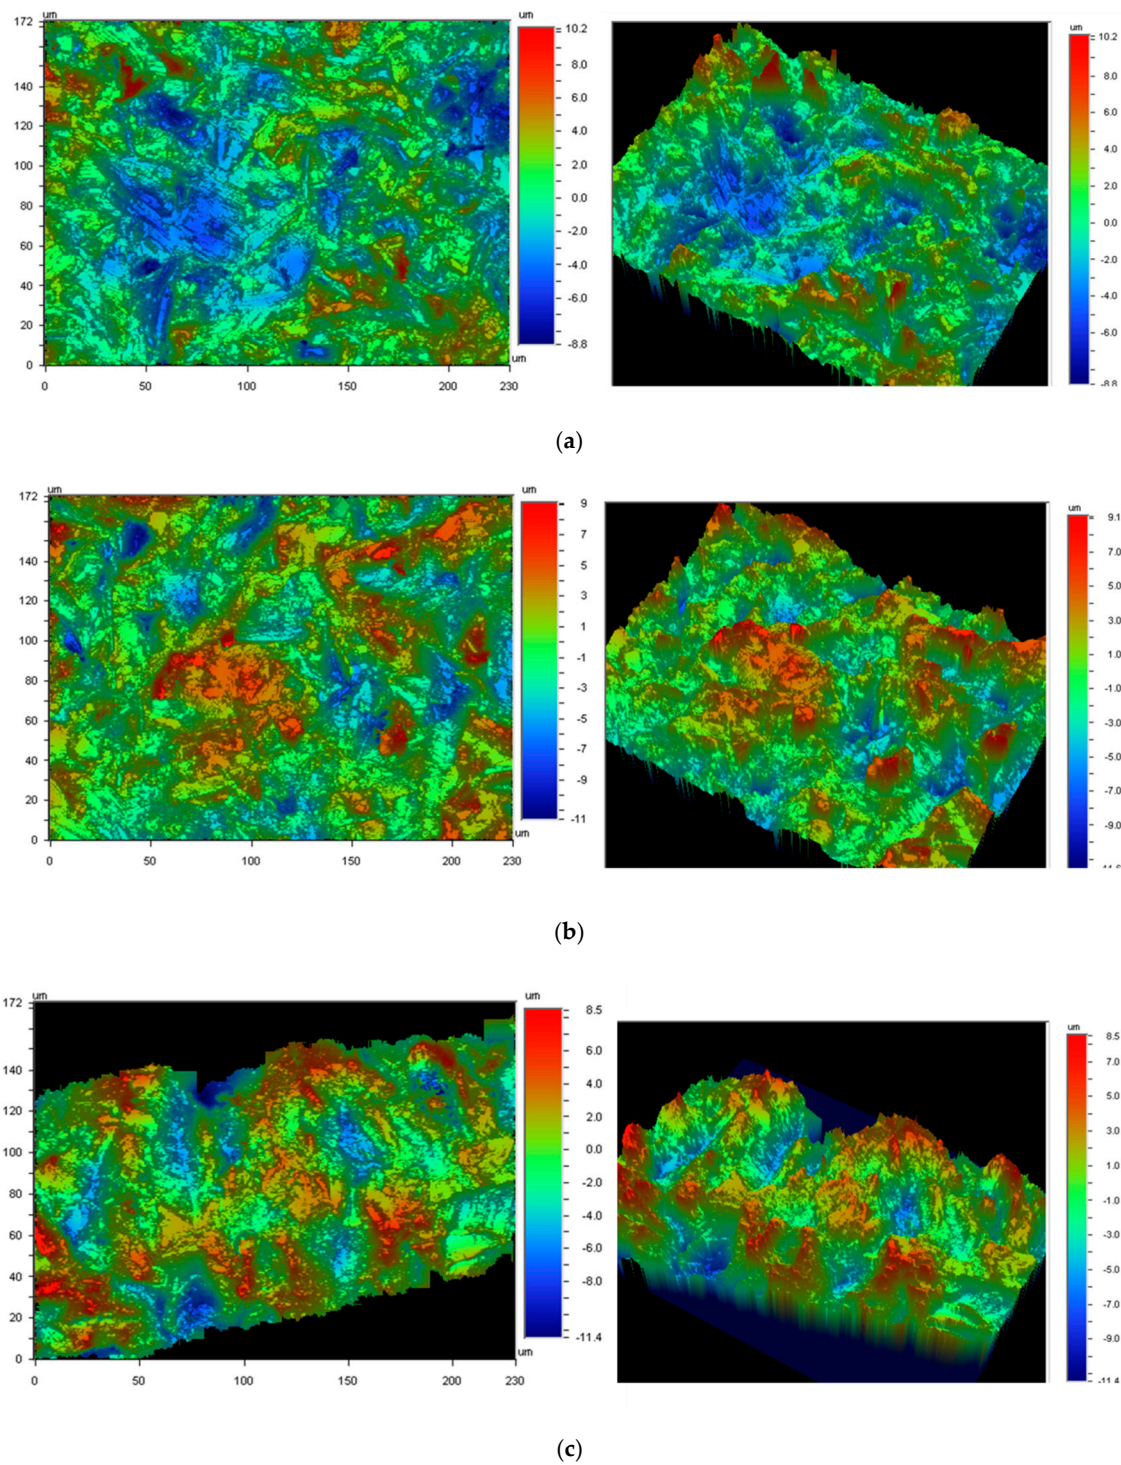
**Figure 6.** Roughness of the different surfaces studied. (a) cp-Ti grade 4 dental implant; (b) Ti-15%Zr dental implant; (c) cold-worked (12%) dental implant. These topographies were obtained by sandblasting with  $\text{Al}_2\text{O}_3$  and acid etching.

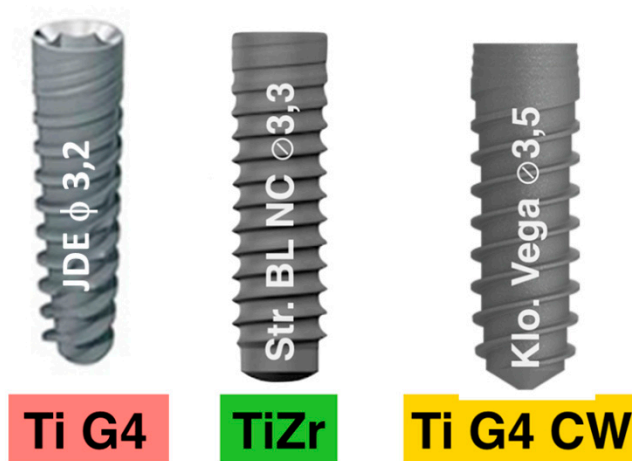
For comparison with other NDIs which were submitted to a hardening processes, such as alloying with 15% Zr or cold-working at 12%, Roxolid<sup>®</sup> by Straumann (Switzerland) and Vega<sup>®</sup> by Klockner (Spain) were used, respectively. The designs and main characteristics are presented in Figure 7 and Table 2. As can be observed, the macrodesign and roughness were very similar.

**Figure 7.** NDIs studied. TiG4: cp titanium grade 4; TiZr: titanium alloyed with 15% Zr; TiG4CW: cp titanium grade 4 cold-worked at 12%.

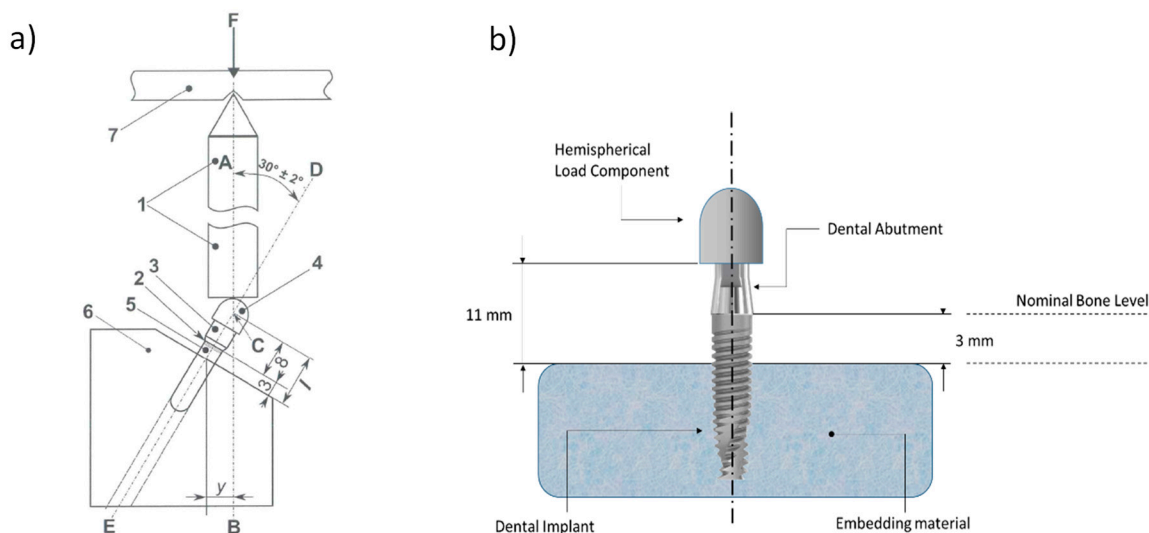
Implants used for mechanical testing were embedded into a polymeric resin to mimic oral conditions before performing any mechanical assay in order to provide a stable support. NDIs were placed perpendicularly at  $3.0 \text{ mm} \pm 0.1 \text{ mm}$  above the nominal bone level described by the different manufacturers in a cold auto-curing polymeric resin (Mecaprex MA2+, Presi, France), as shown in Figure 8.

**Figure 8.** (a) Overall scheme of the mechanical testing described by the ISO 14801 standard. (b) Front view of representative drawing with lengths and distances of the testing samples.

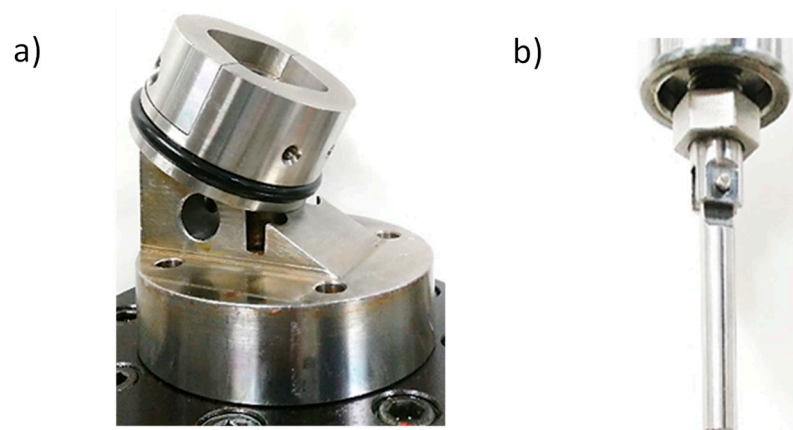
The dynamic cyclic fatigue assay was carried out in a triaxial compression–flexion–torsion mode, placing the NDI implants fixed with an inclination of  $30^\circ \pm 2^\circ$  of the compression stress application axis with the z-axis with respect to the tensile compression machine (Figure 9), under sinusoidal load at  $30^\circ$  and 15 Hz at room temperature under dry conditions [33]. The data were represented as the number of cycles reached at fracture for different applied forces. The deformed and fractured specimens were observed by means of field-emission scanning electron microscopy (JSM 7100, Jeol, Tokyo, Japan).

**Figure 9.** Detail of the fatigue testing grips used by servo-hydraulic testing machine: (a) lower clamping grip; (b) upper articulated grip.
