Article

# Recovering Industrial Heritage: Restoration of the Wine Cellar Cooperative in Falset (Catalonia, Spain)

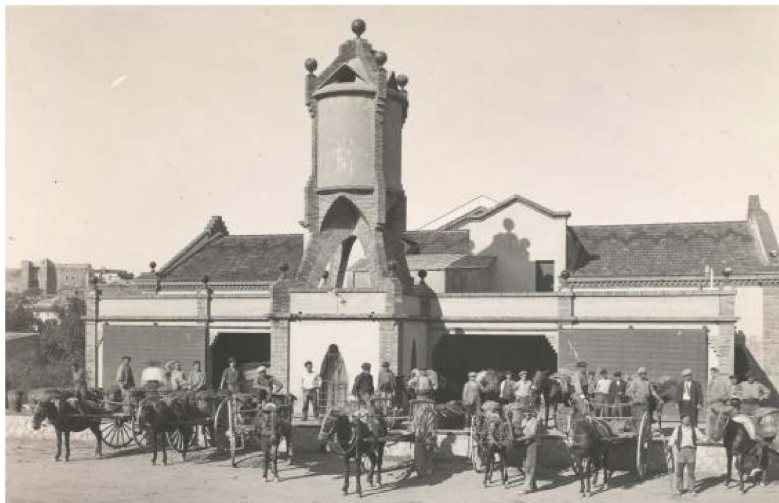
**Figure 1.** Old picture of the cooperative wine cellar in Falset.

The Catalan region of Priorat and Conca de Barberà is known for its expertise in wine production. During the first years of the 20th century, a characteristic type of wine cellar, known as the “Wine Cathedrals”, appeared. The architectural features of these buildings, based on the principles of Art Nouveau, turn them into one of the leading exponents of the industrial heritage of Catalonia (Figure 1).

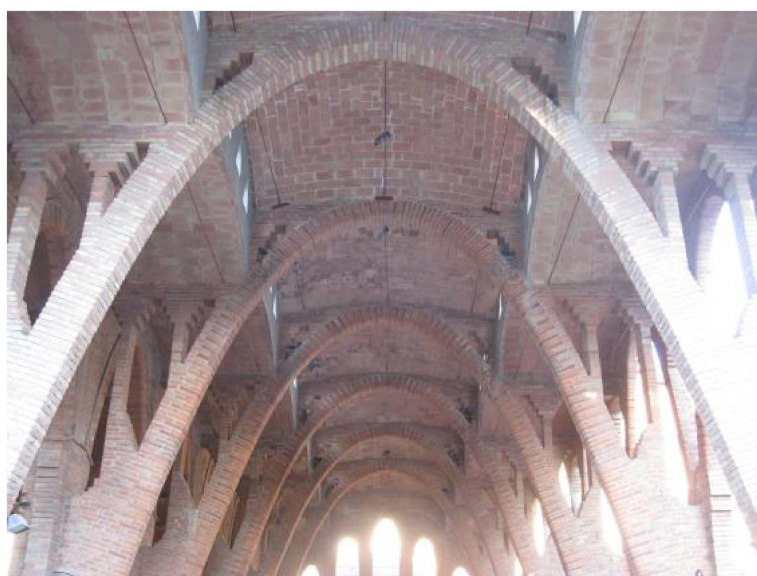
**Figure 2.** Parabolic arches used as a structure in the cellar of Sant Cugat by Cèsar Martinell, 1921.

Regarding the constructive aspects of winery cooperatives, the ways of covering this great space were also inspired by traditional architecture. For example, Pere Domènech i Roura, responsible for the winery of L'Espluga de Francolí, used pointed diaphragm arches to support the roof of the building, a system that had its origins in the Civil Catalan Gothic. This Gothic system in cellars, however, was soon replaced by parabolic arches (Figure 2), which were often used by Antoni Gaudí.

The most important structural feature of the parabolic arches, and what sets them apart from other structural forms, is that the direction of the stress follows the line of the arch for uniformly applied loads. Their shape makes for optimum use of the material, and they are only subject to compression, without needing anchors or buttresses to ensure that the inclined load is transferred to the foundations. The construction of brick parabolic arches, the ones used in modernist wine cellars, was a highly optimized system because they used local materials, that were cheap and readily available, required little transport and used a traditional and well-known construction technique.

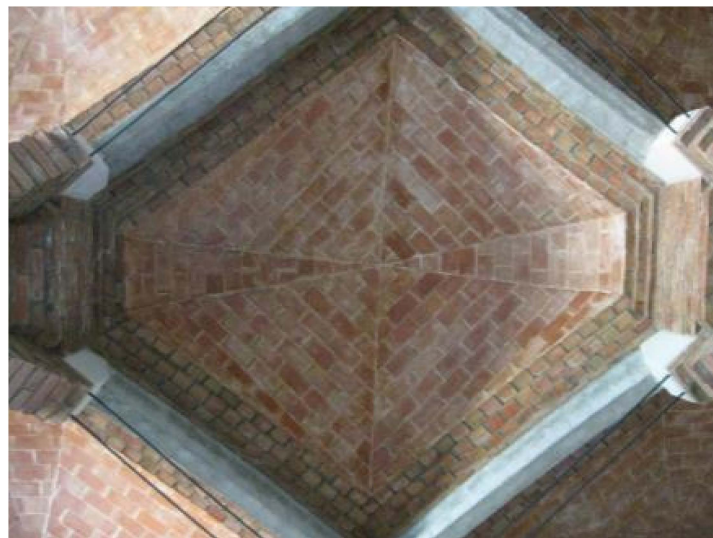
**Figure 3.** Catalan vault in the interior of the Gandesa cellar by Cèsar Martinell, 1919.

The Catalan vault or flat brick vault (*volta catalana*, or *volta de maó de pla*) (Figure 3) is another contribution of traditional architecture; it dates back to ancient Rome, but in Catalonia it was one of the most frequently used constructive elements in farmhouses and popular urban constructions. In this case, bricks are placed on their wide side forming a surface that covers the ceiling. Vaulted ceilings provide the building with great homogeneity, both visually and structurally, as they consist of a single material, which means thermal expansion and contraction is uniform and cracking is avoided. Furthermore, the tiled dry roof makes easier the ventilation of the spaces where wine is made or stored. As far as construction is concerned, this system optimizes the efficiency of the material because structurally it takes advantage of the entire cross section. Catalan vaults were not only used on the roofs of wine cellars, but also in the construction of underground water or wine tanks, in the construction of retaining walls to restrain soil or in the construction of separated vat bases on anchored arches.

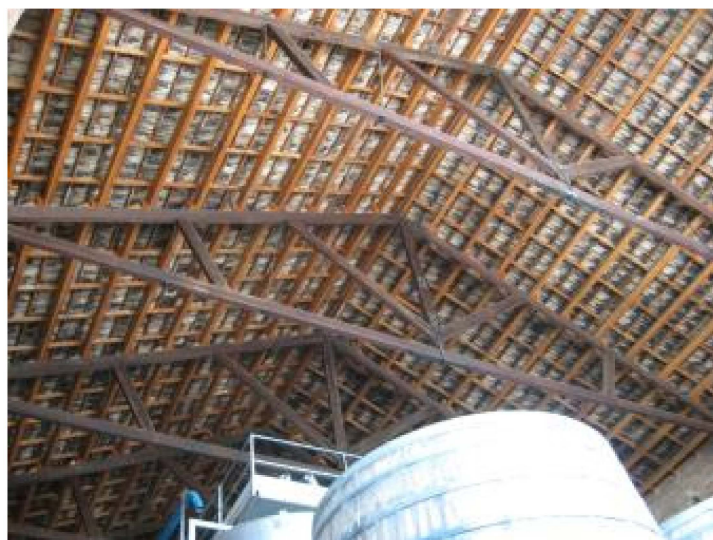
**Figure 4.** Wood roof trusses in the Falset cellar by Cèsar Martinell, 1919.

Wood roof trusses (recovered by architects such as Lluís Muncunill in vernacular architecture) (Figure 4) were also widely used in cooperative wine cellars. Roof trusses are building systems

that consist of a triangular framework—comprising a series of wood or metal beams properly put together—used to bear the weight of pitched roof tiles. They are characterized by the fact that the elements of the structure only resist compressive or tensile stresses, but not bending stresses (unlike ordinary beams). This enables an optimum use of the structure, covering large surfaces at a lower cost than when using beams.

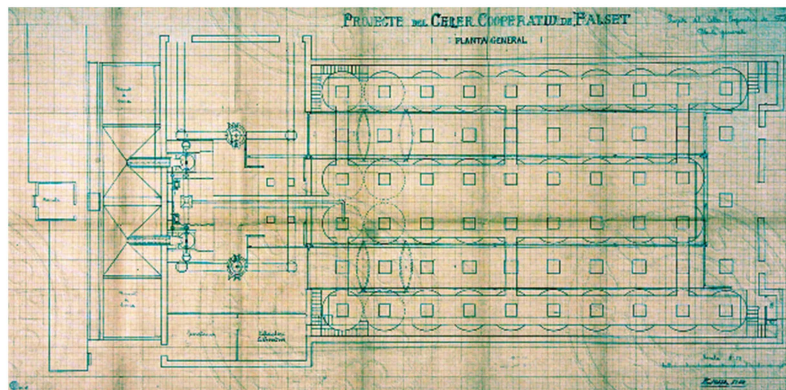
Figure 6. Cèsar Martinell, original floor plan of the wine cellar in Falset, 1919.

The fermentation containers, which were originally made of oak and now of stainless steel, are located in the three naves of the main building, occupying an area of 23.5 m × 37.5 m. There are still two original wooden containers used for making *vermut*, a dry wine for appetizers. The vats are arranged in two rows in the central area and one in each side area (Figure 6). They are elevated and supported by Catalan vaults, in order to separate them from the ground and use the space underneath for storing tools. Below this floor there are underground containers used for the second fermentation.

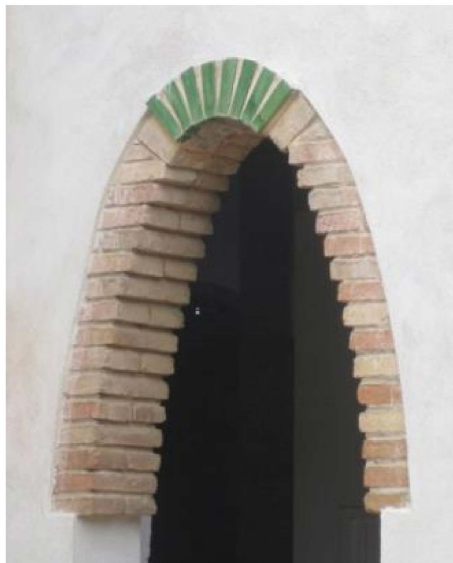
Figure 7. Parabolic arch on one of the doors.

The roof covering structure of the main building consists of a 15-m-span wood roof truss that leans on brick pillars. The roof of the secondary building is also composed of a wood roof truss of approximately 12 m. Roof tiles were used to clad the roofs; the roof made of French tiles ensures proper ventilation inside the building. Some of the tiles are made of green polychrome ceramics, creating a saw-shaped frieze on the two sides of the main roof. Glazed tiles emphasizing the eaves of the roof are also found on the main and side façades of the building. The absence of structural parabolic arches on the roof of the cellar supposes a big difference in Falset, because of the lack of these defining elements in Martinell's architecture. Parabolic arches, nevertheless, appear in other parts of the building, as doors or windows (Figure 7).

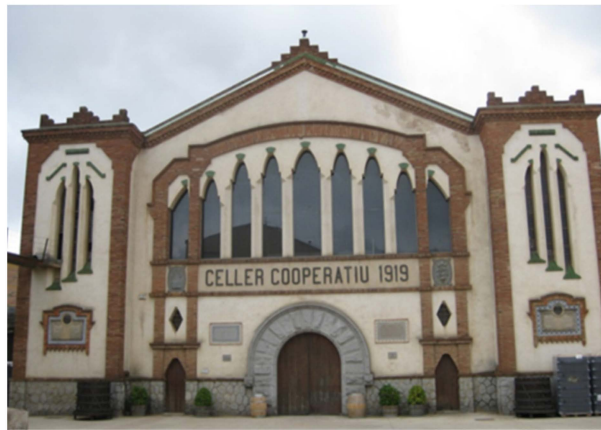
**Figure 8.** Main façade of the building.

The main façade of the building has two square plan towers at the extremes, with crenellated mouldings and brickwork in the corners, giving a medieval air to the construction (Figure 8). Cèsar Martinell took into account Falset's medieval tradition in the design of the façade of the wine cellar because, as he said, it was important to look at the past to build the present. In the center of this façade, a big granite midpoint arch is opened as the main entrance of the building (Figure 9). On top of this entrance, in the center of the façade, there are a group of nine narrow and elongated parabolic windows, framed with bricks. These windows are joined under a single discharging arch leaning on four pilasters. The motif of narrow parabolic windows is repeated in the secondary building.

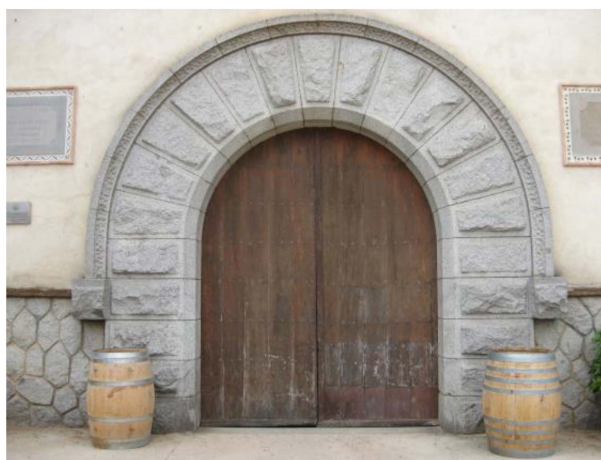
**Figure 9.** Medieval influence in the midpoint arch of the entrance.

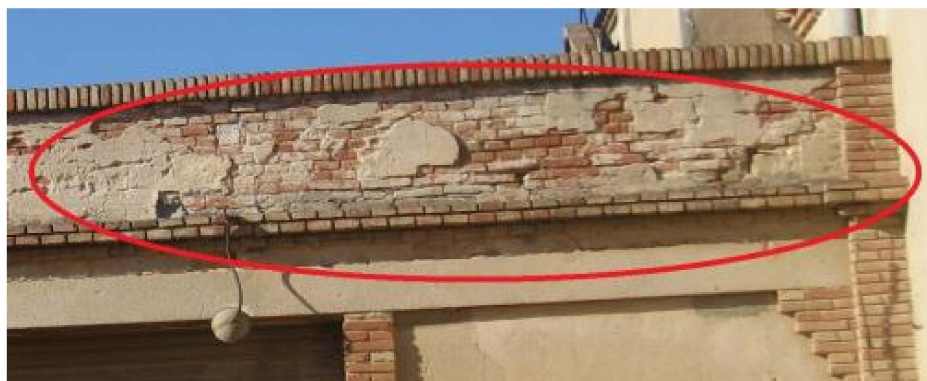
**Figure 11.** Loose render on the walls of the façade.

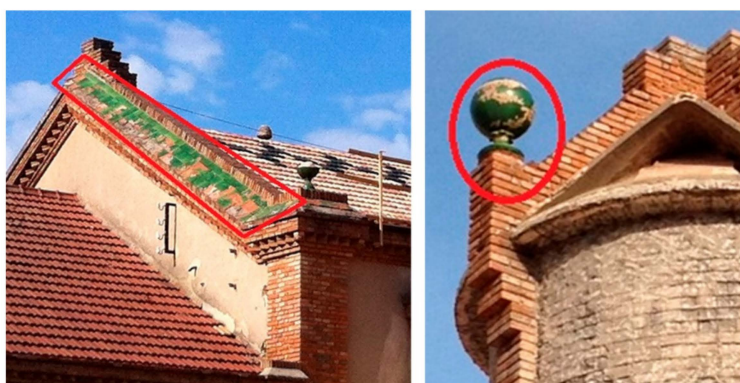
**Figure 12.** Deterioration of the decorative green ceramics on the roof and on the spheres of the water tank.

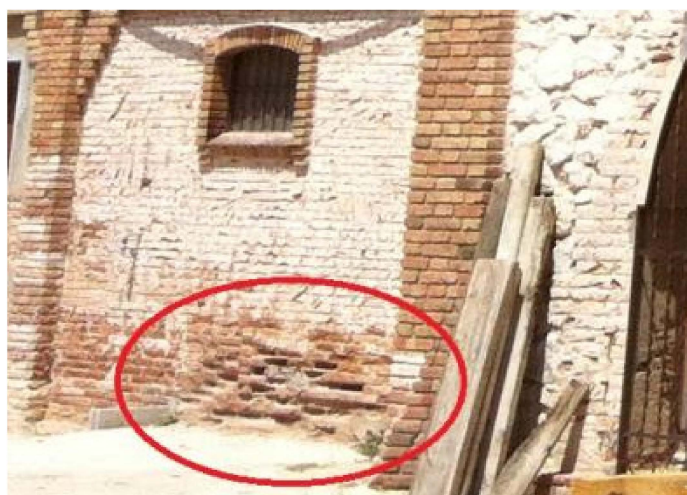
Deterioration of the base of the walls of the façade (Figure 13).	Erosion by atmospheric agents and soil moisture.	The affected areas were filled with expansive mortar, and cladding was applied uniformly on all the façades.
Addition of material that was not original to the façade due to old repair work carried out (Figure 14).	Old repair works.	Completely replacing the cladding of the façade.
Dampness on the walls of the façade: on some parts of the façade (mainly around the drainage pipes of the building) there were damp stains (Figure 15).	Incorrect installation when replacing the original ceramic drainage pipes and lack of a waterproof sheet on the flat roof of the unloading nave.	Removing the surface of the flat roof, installing a waterproof sheet and paving the surface again.
Cracks in the walls of the façade and in the water tank: In some parts of the building there were cracks in the top part of the wall of the façade, which went all along the edge of the roof slab (Figure 16 left) and in the walls of the water tank (Figure 16 right).	Expansion and contraction movements originated by exposure to atmospheric conditions. The cracks had no movement.	Removing the old render, manually cleaning the joints with a steel brush, and filling them again with a new mortar, which is less stiff and more resistant to the bending of cement and glue, and finally coating the surface.

**Figure 13.** Deterioration of the base of the façade.

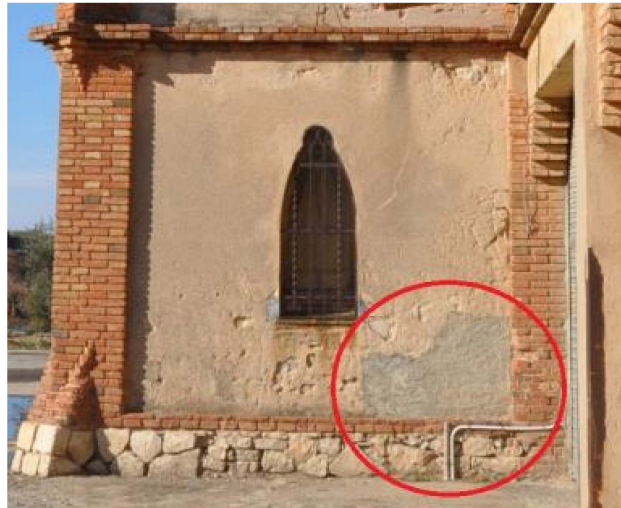
Figure 14. Addition of material that was not original to the façade.

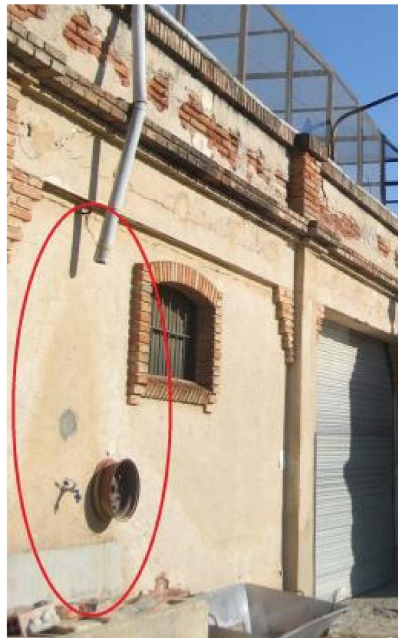
Figure 15. Dampness on the façade.

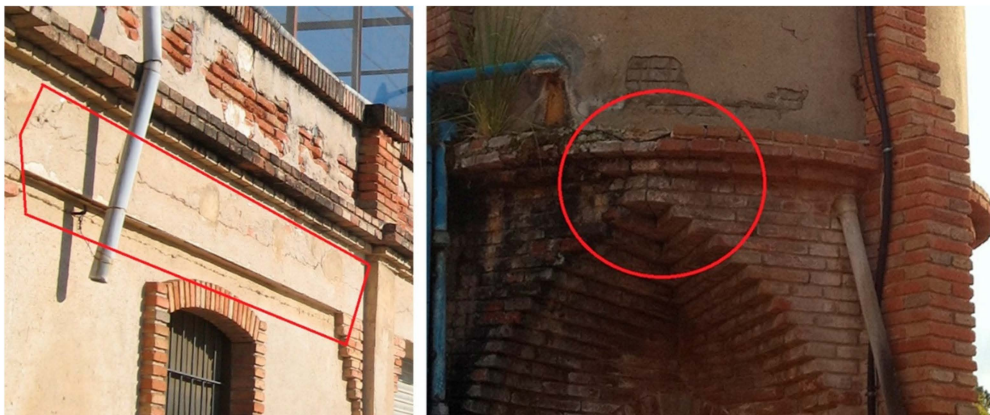
Figure 16. Cracks in the top part of the façade and in the water tank.

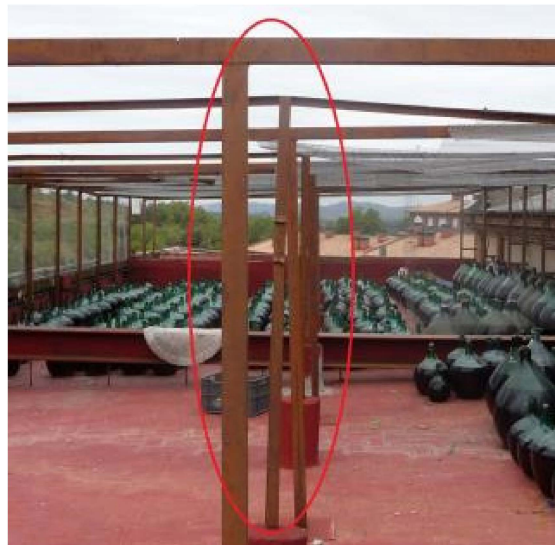
Damage	Cause/Agent	Repair
Rusting of the iron elements on the flat roof of the unloading nave, which presented different levels of rusting (Figure 17).	Exposure to aggressive atmospheric agents and to a lack of maintenance.	Removal of iron elements and change of the entire surface of the flat roof.
Dampness on the flat roof of the unloading nave (Figure 18).	Loss of the appropriate slope of the flat roof and the deterioration of the waterproof sheet (due to atmospheric agents and a lack of proper maintenance).	Removal of the surface of the flat roof, installation of a waterproof sheet and paving the surface again.
Erosion of the material on the roof of the unloading nave: Parts of the surface of the flat roof of the unloading nave showed different levels of erosion (Figure 19).	Atmospheric agents and a lack of proper maintenance.	Removal of the surface of the flat roof, installation of a waterproof sheet and paving the surface again.

Figure 17. Rusting of metal structures on the flat roof.

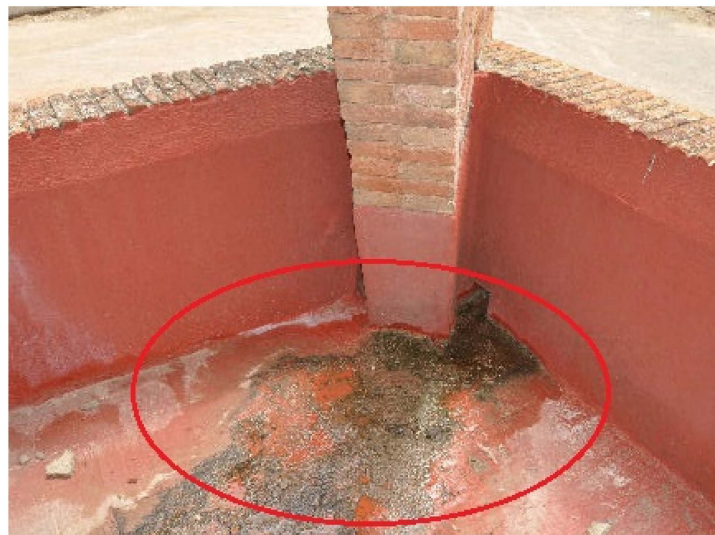
Figure 18. Dampness on the surface of the flat roof.

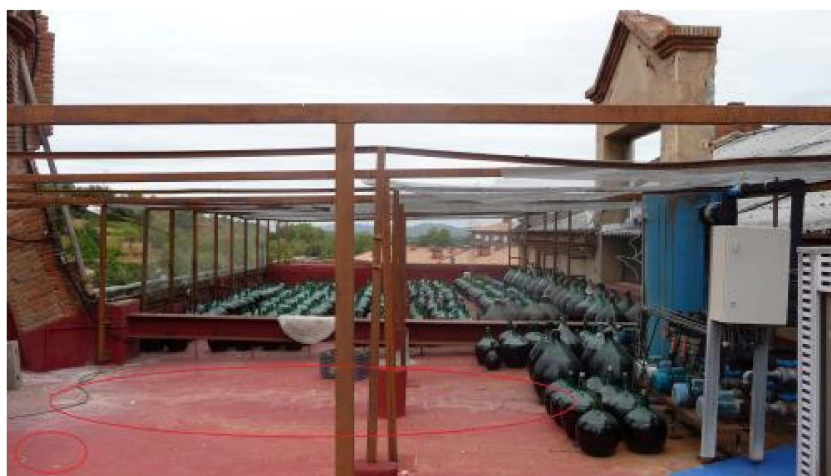
Figure 19. Deterioration of the surface of the flat roof.

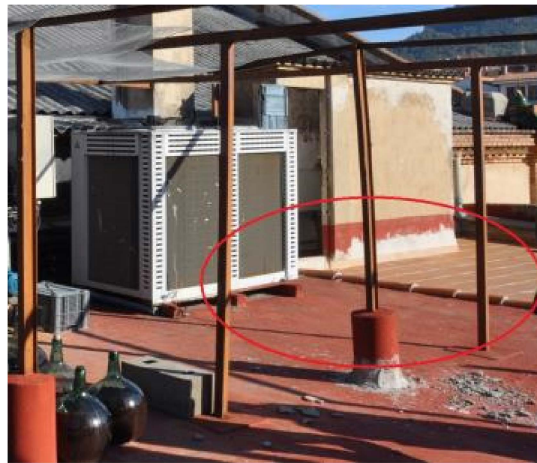
Discordant paving materials on the flat roof of the unloading nave: Some parts on the flat roof of the unloading nave had different kinds of paving (Figure 20).	Previous repairs. Different paving materials behaved differently in front of atmospheric agents.	Removal of the surface of the flat roof, installation of a waterproof sheet and paving the surface again.
Dampness and loss of permeability on the roof of the wine-production nave: There were several broken fiber cement sheets on the roof, which could not guarantee the permeability of the nave (Figure 21)	Deterioration of the roof materials due to the effects of atmospheric agents and to a lack of maintenance.	Entire replacement of the wine-production nave roof.
Dampness on the bearing wall of the structure on the roof of the wine-production nave: The gutters collecting rainwater on this roof were in very poor condition (Figure 22).	Atmospheric agents and a lack of maintenance.	Entire replacement of the wine-production nave roof.

Figure 20. Discordant paving on the flat roof.

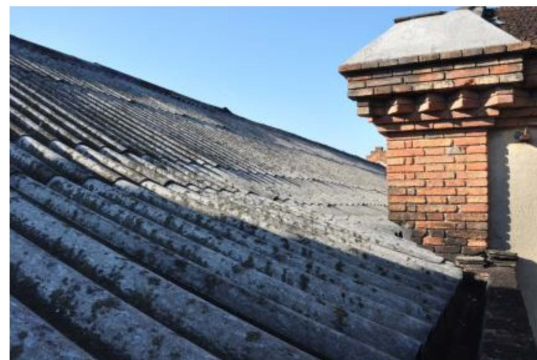
Figure 21. Condition of the roof of the wine-production nave (exterior) before restoration.

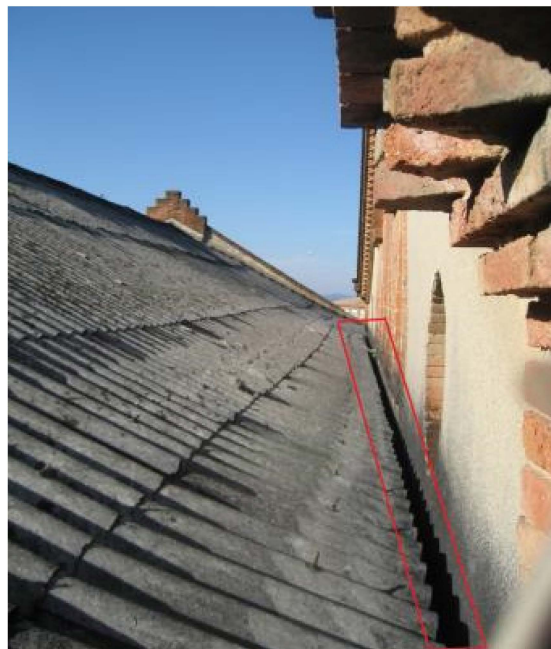
Figure 22. Dampness in the joint between the roof and the façade.

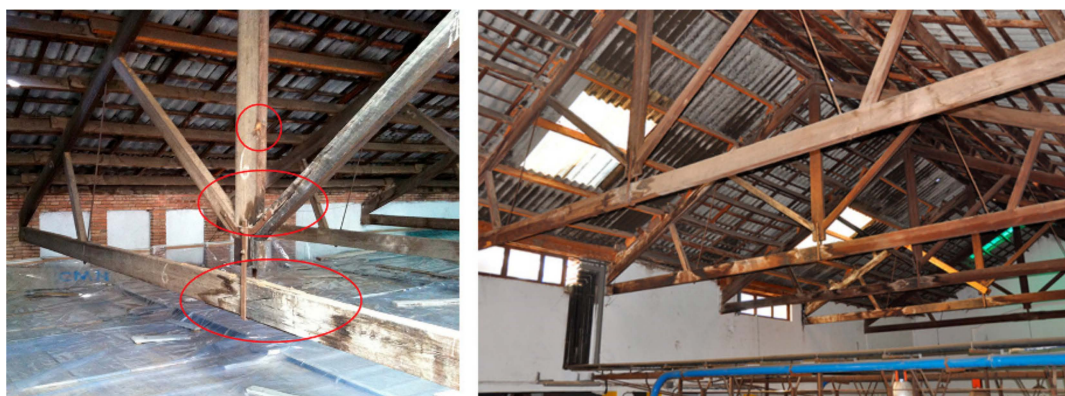
Figure 23. Condition of the production nave roof (interior) before restoration.

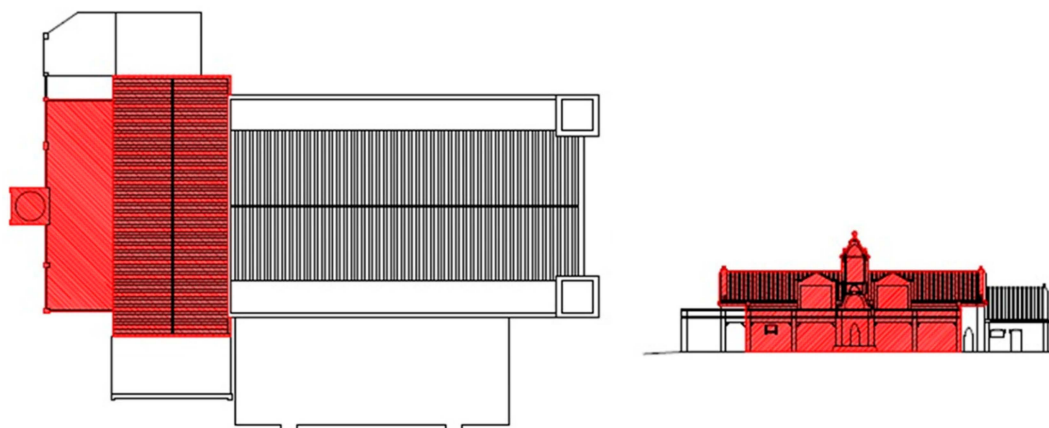
Figure 24. Restorations carried out.

The main restoration works, in addition to the punctual and simple repairs of other elements mentioned above, revolved around the façade of the wine-production nave of the cellar, including the elevated water tank. The roof of the wine-production nave was also restored and an access to the flat roof of the unloading nave was built (Figure 24).

The building solution used on the roof allows natural ventilation of the wine cellar without losing its function of protecting from rain. It was essential to encourage recycling the air inside and getting rid of the steam produced by the winemaking process. The original dormer windows in the wine-production nave were also recovered, and the space was provided in this way with the necessary light to substantially reduce electricity costs. Furthermore, the location of the machines and the pipe runs of the water-cooling system were rationalized.

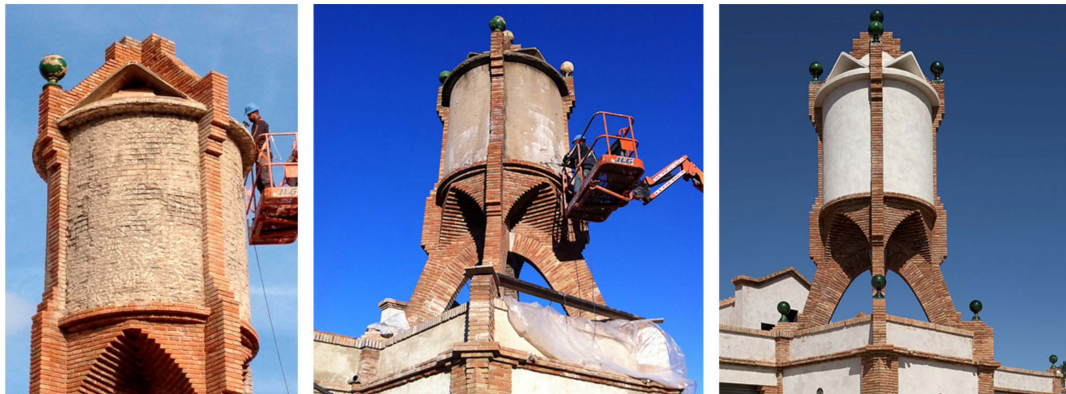
**Figure 25.** Water tank during restoration (**left and center**). Water tank after restoration (**right**).

First of all, the cracks of the exposed brickwork were mended, substituting the deteriorated parts and repairing the mortar joints. The decorative elements and the finishes of the façade and the water tank were recovered (Figures 25 and 26). Finally, the lime mortar render was repaired and painted.

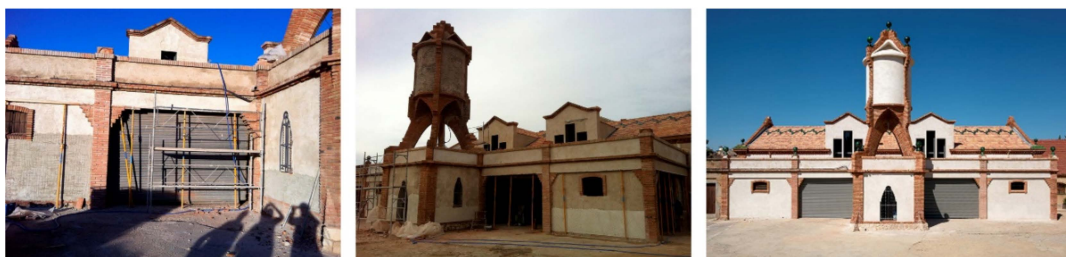
**Figure 26.** Back façade during restoration (**left and center**). Back façade after restoration (**right**).

The reparation of the walls of the exterior façade consisted in the following actions: removal of loose render; cleaning of joints up to 2 cm of the exterior wall; applying a coat of levelling mortar to the exposed brickwork; applying a two-coat (10 + 10 mm) base mortar finish; applying two coats of aerated lime plaster; surface cleaning; and finally applying a PH neutralizer.

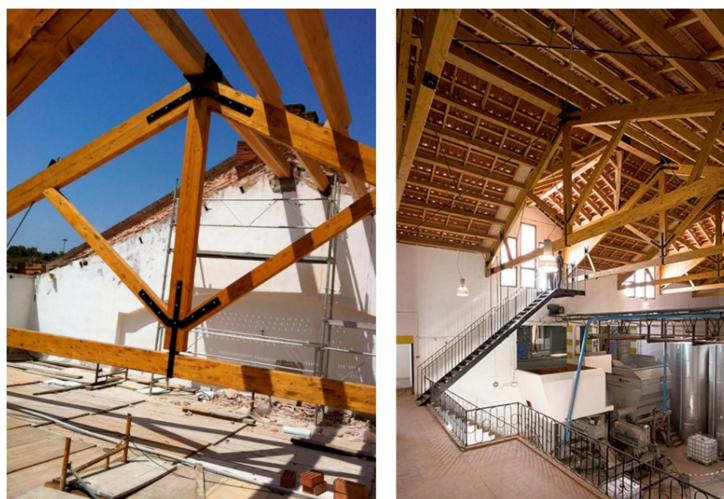
**Figure 27.** Roof structure of the wine-production nave during restoration (**left**). Roof structure of the wine-production nave after restoration (**right**).

The original volumetric, building system and materials of the roof of the wine-production nave were recovered (Figure 27). The structure of the roof was rebuilt following the plans of the original roof, which consisted of a main structure comprised of laminated wooden roof trusses, a flanders pinewood sub-structure, tiling battens, joist brackets and complementary steel tensioners.

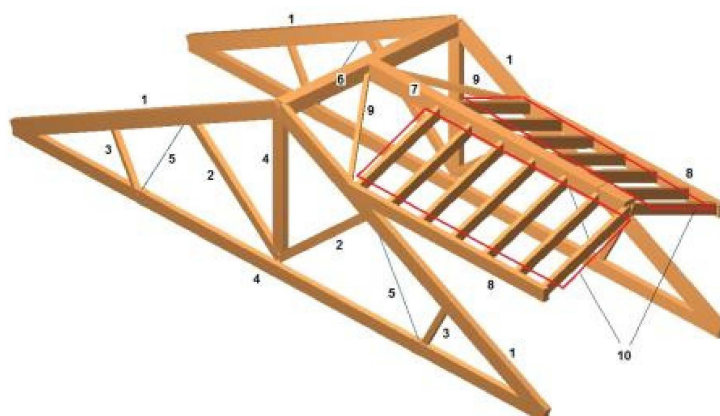
**Figure 28.** Diagram of the calculation of the wood structure of the roof.

The initial idea was to recover the original roof trusses, but they were so badly deteriorated that it was more economical to change the entire structure. The measuring of the new wood truss was carried out using a structure calculation program in three dimensions called Metal 3D, from the CYPE Company. A model of the structure of the roof is shown below (Figure 28) (all the roof trusses have the

same dimensions and so have the dormer windows structures), as well as a table with the dimensions of the different bars (Table 3).

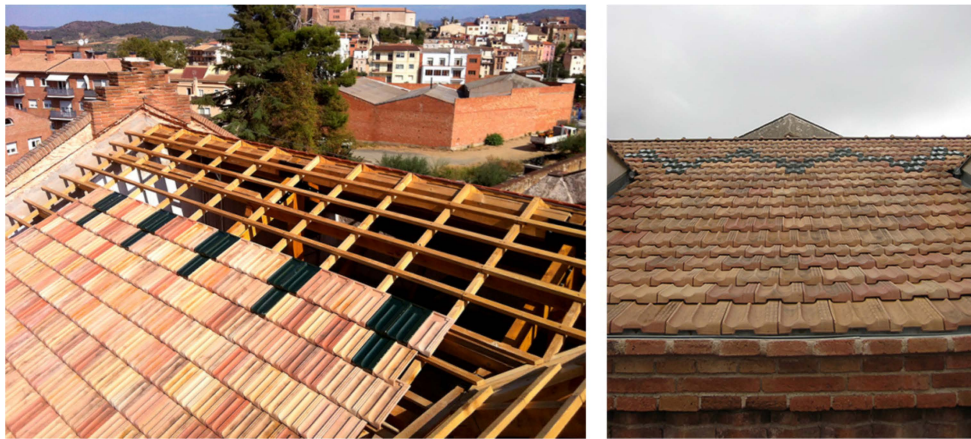
**Figure 29.** Roof of the wine-production-nave during restoration (exterior detail of tiles) (**left**). Roof of the wine-production nave roof after restoration (exterior detail of tiles) (**right**).

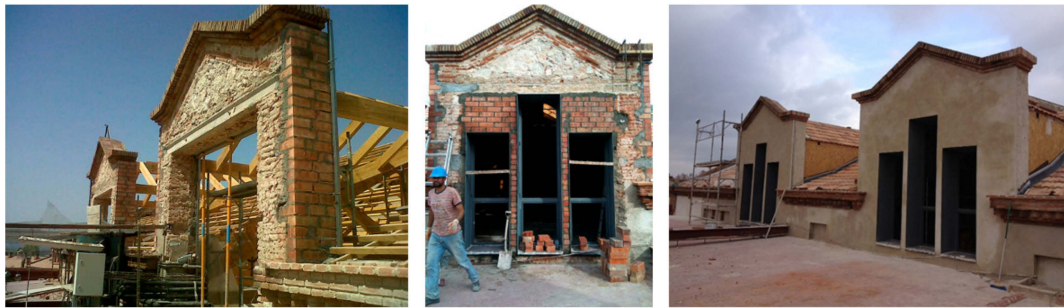
**Figure 30.** Dormer windows of the production nave during restoration (**left and center**). Dormer windows of the production nave after restoration (**right**).

When building the roof of the wine-production nave, it was observed that, originally, the dormer windows (which were glazed and lit part of the wine-production nave) were integrated into the roof volume. Furthermore, in order to access the flat roof of the unloading nave it was necessary to go through one of the dormer windows. Repairing the roof of the wine-production nave thus meant recovering those obsolete dormer windows as well as building a suspended staircase to connect the inside of the wine-production nave to the roof of the unloading nave. The existing staircase was removed, drawing the roof profile of the nave again, in the same way Cèsar Martinell had designed it.

By recovering and integrating the original dormer windows into the roof volume, the front part was built using wood carpentry and the sidewalls were brickwork walls rendered with lime mortar on the new roof trusses (Figure 30). A door was added to the dormer window facing east so as to have access to the roof from the inside of the wine-production nave.

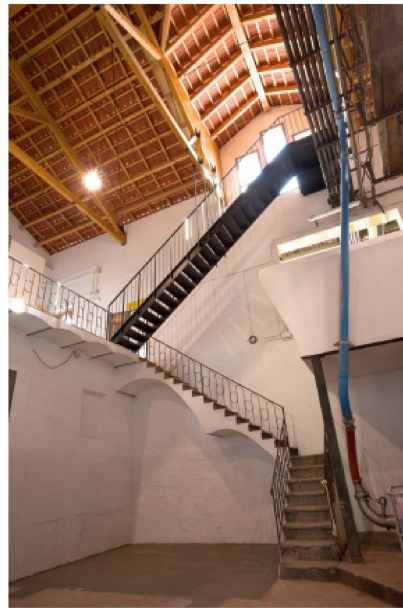
**Figure 31.** New staircase access to the restored roof of the unloading nave.

First of all, the silo in disuse in the wine-production nave was demolished. The adjacent staircase was also demolished and new stairs were built. After this, an access to the flat roof through the wine-production nave was made. This access consisted of a steel staircase suspended from the main structure of the roof of the production nave, and it was made through the new openings of the dormer windows, thus recovering the idea of Cèsar Martinell's project (Figure 31).
